# Copper emissions from antifouling paint on recreational vessels

Kenneth Schiff<sup>\*1</sup>,  
Dario Diehl<sup>1</sup>,  
Aldis Valkirs<sup>2</sup>

Technical Report #405

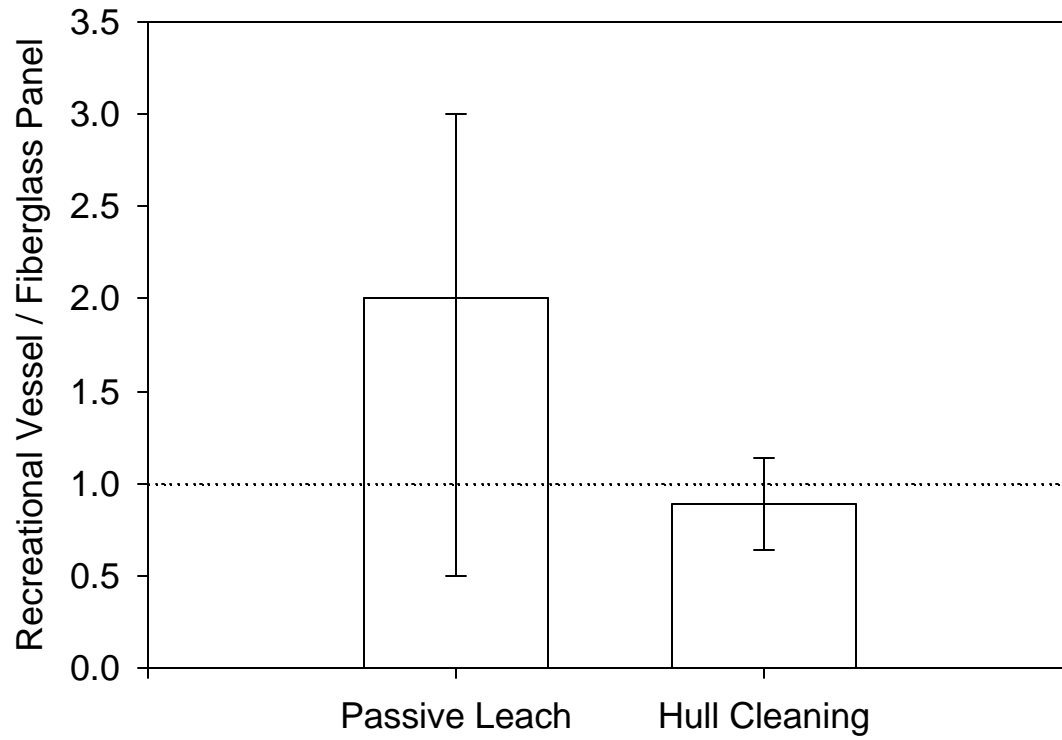
**Figure 3. Ratio of mean (min, max) dissolved copper flux rates for passive leaching or hull cleaning activities from recreational vessels relative to fiberglass panels used in this experiment. Data for passive leaching from recreational vessels from Valkirs *et al* (2003).**

One point of concern for our study design was extrapolation of our results from fiberglass panels to the hulls of recreational vessels. This concern appears unfounded, though, because our measurements compared favorably to measurements from recreational vessel

hulls (Fig 3). Valkirs et al. (2003), using the *in situ* methodology used in our study, reported passive leach rates on seven different recreational vessels of varying coating formulations with different copper content, time since application, and time since cleaning. The mean passive leach rate of the recreational vessels was approximately double the fiberglass panels (8 vs. 4  $\mu\text{g}/\text{cm}^2/\text{day}$ ), but the range of measurements for the vessels encompassed the mean of our panel system. In fact, the range of measurements for the seven different recreational vessels was within the range of measurements for the fiberglass panels (2-26  $\mu\text{g}/\text{cm}^2/\text{day}$ ) over our one month test period. Likewise, the flux rates measured during hull cleaning events using fiberglass panels were comparable to results measured from recreational vessels (Fig 3). Similar to isolating fiberglass panels in a dockside tub system, we were able to measure replicate vessels by isolating them from the marina environment using a boat bag. The mean cleaning flux rate measured for the fiberglass panels and the boat bag systems were within 12% of each other. The range of hull cleaning flux rates from recreational vessels appeared much smaller than the passive leaching flux rates, perhaps because the vessels were all similar in size, coating formulation, time since application, and time since cleaning.
